## Fort Campbell Childers House

Historic Maintenance and Repair Manual

September 2006

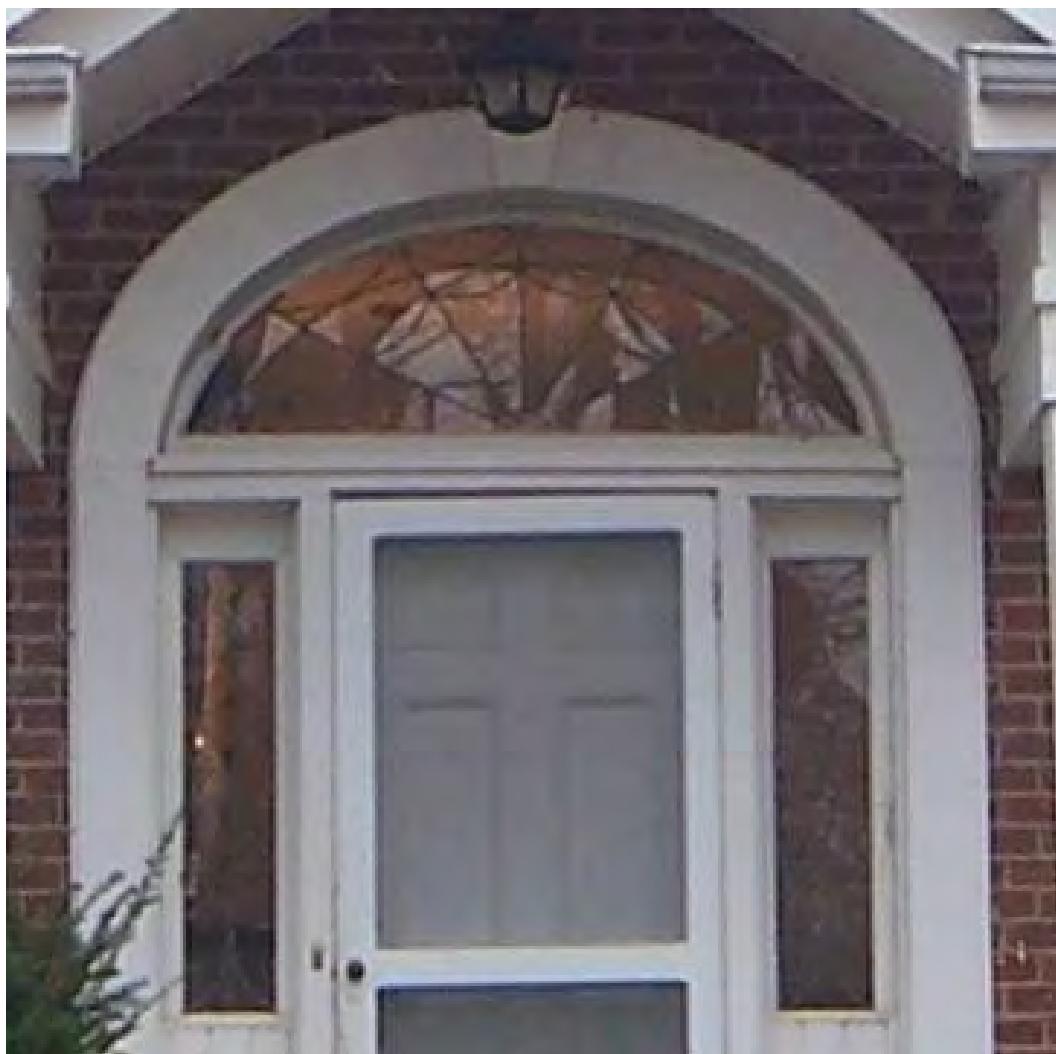
Figure 100. Aluminum covered wood sidelights and panels.

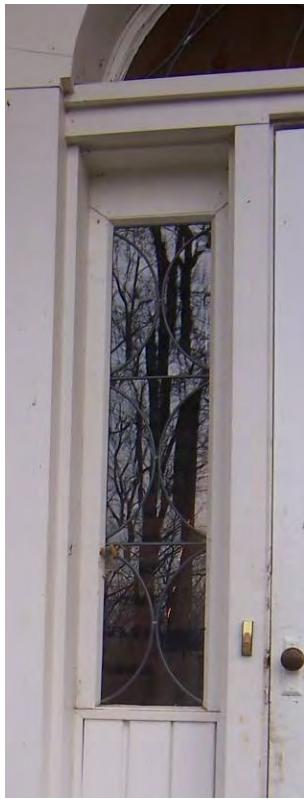
Figure 101. Closeup of aluminum covered wood sidelights and panels.

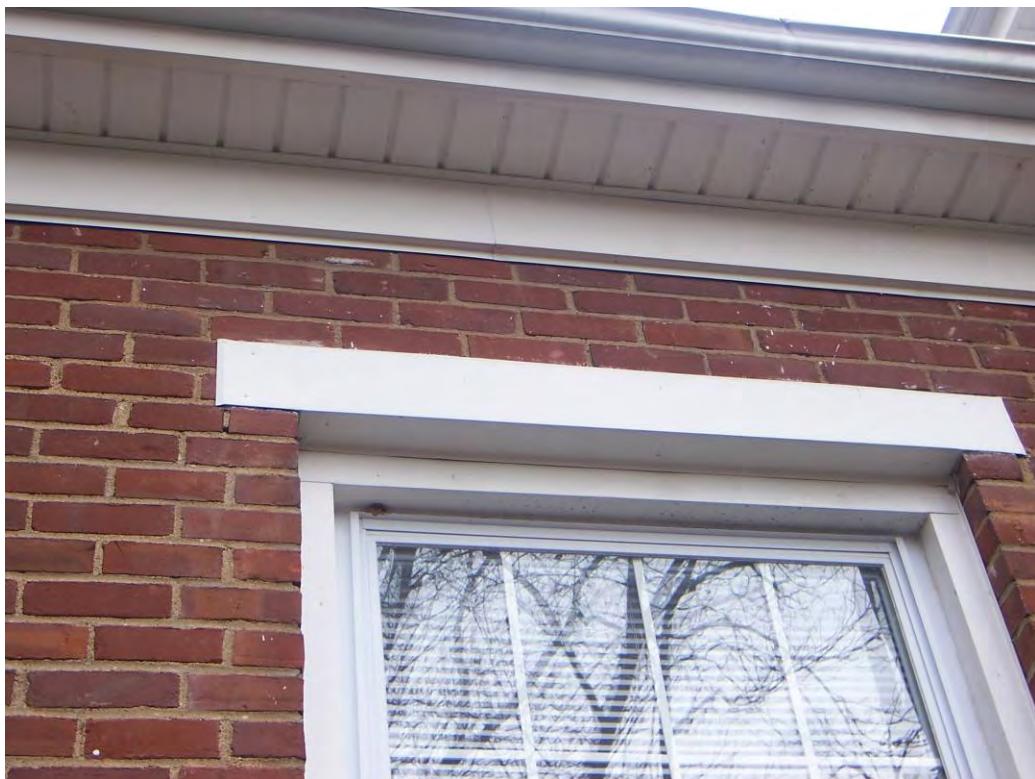
Figure 106. Closeup of replacement window and metal covered lintel.

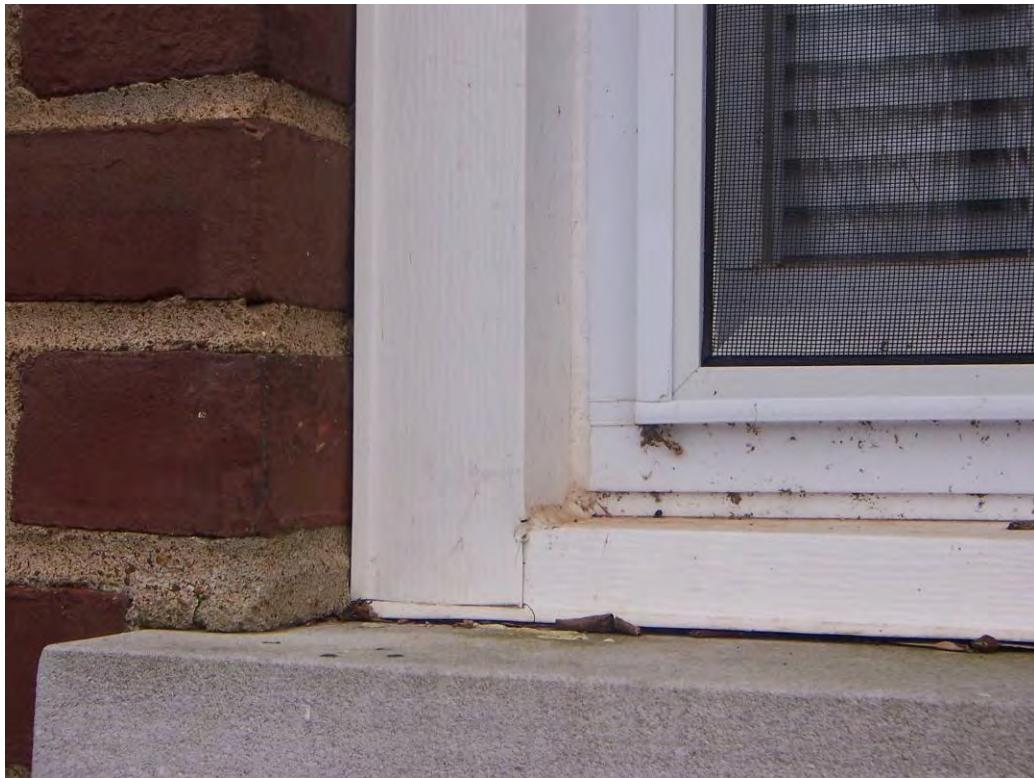
Figure 107. Closeup of aluminum covered window trim.

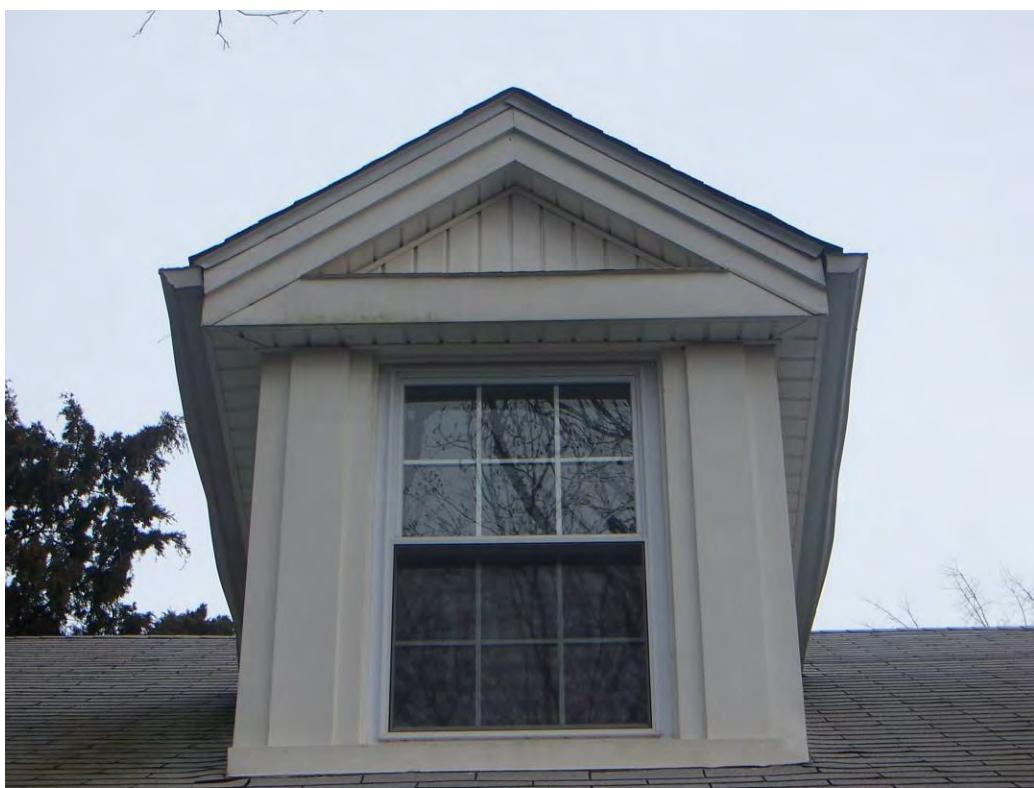
Figure 108. Closeup of replacement window and aluminum covered wood trim.

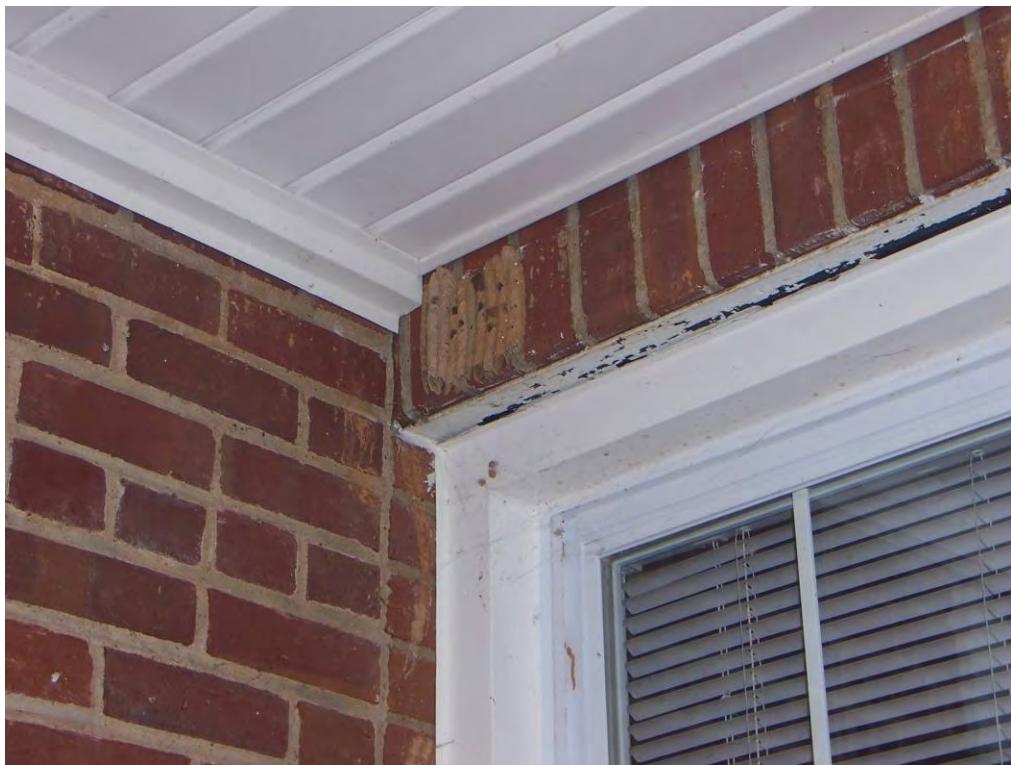
Figure 109. Closeup of replacement window set into original frame.

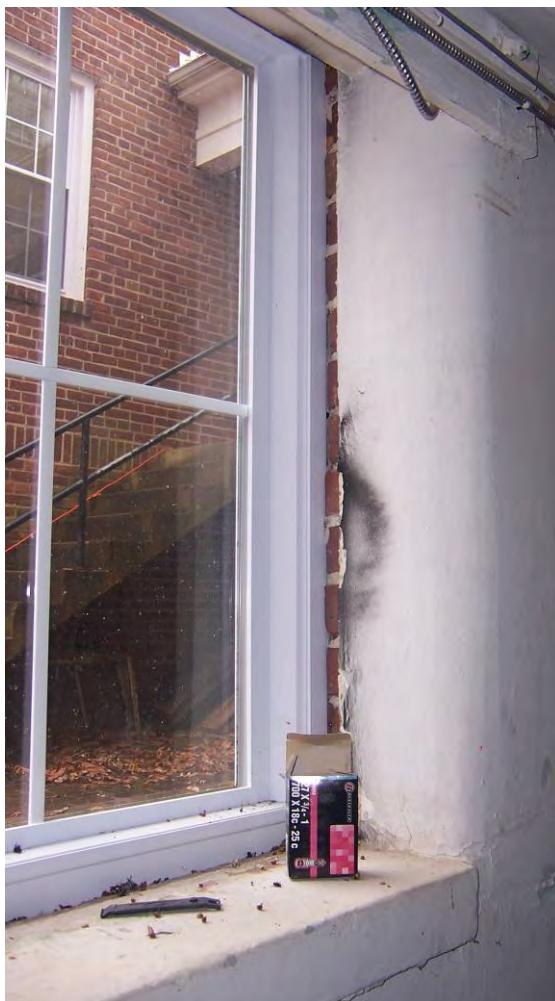
Figure 112. Interior of replacement basement window with exposed brick.

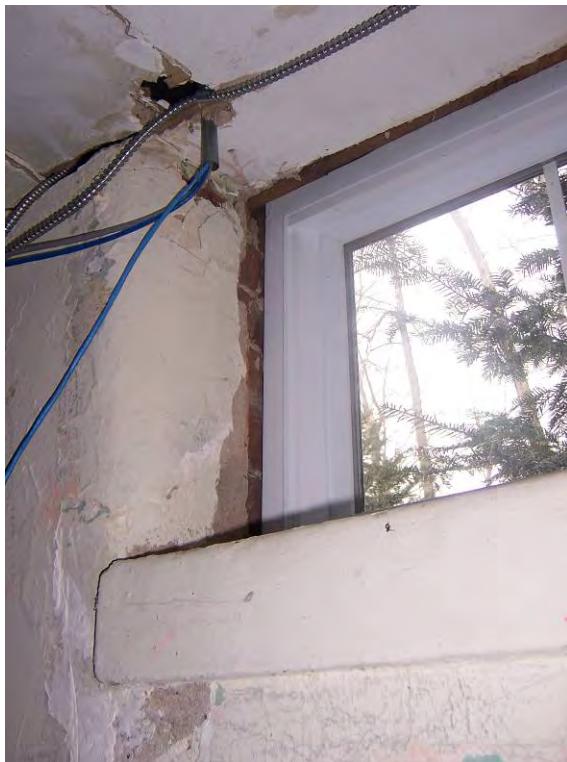
Figure 113. Interior of replacement basement window with exposed brick.

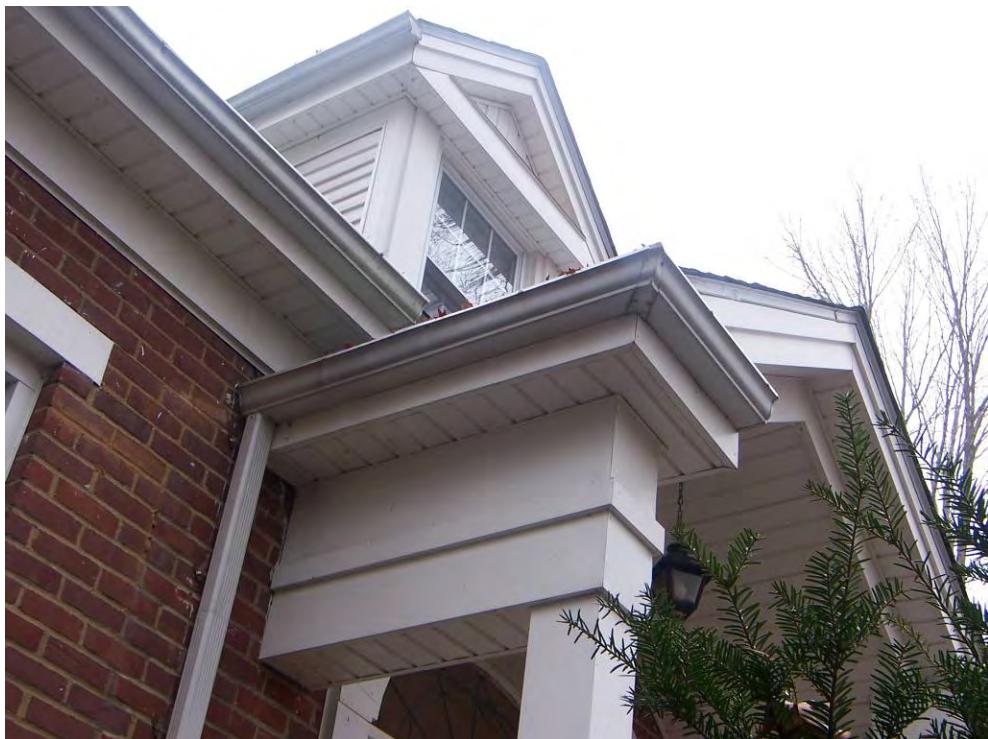
Figure 120. Metal covered decorative wood elements.

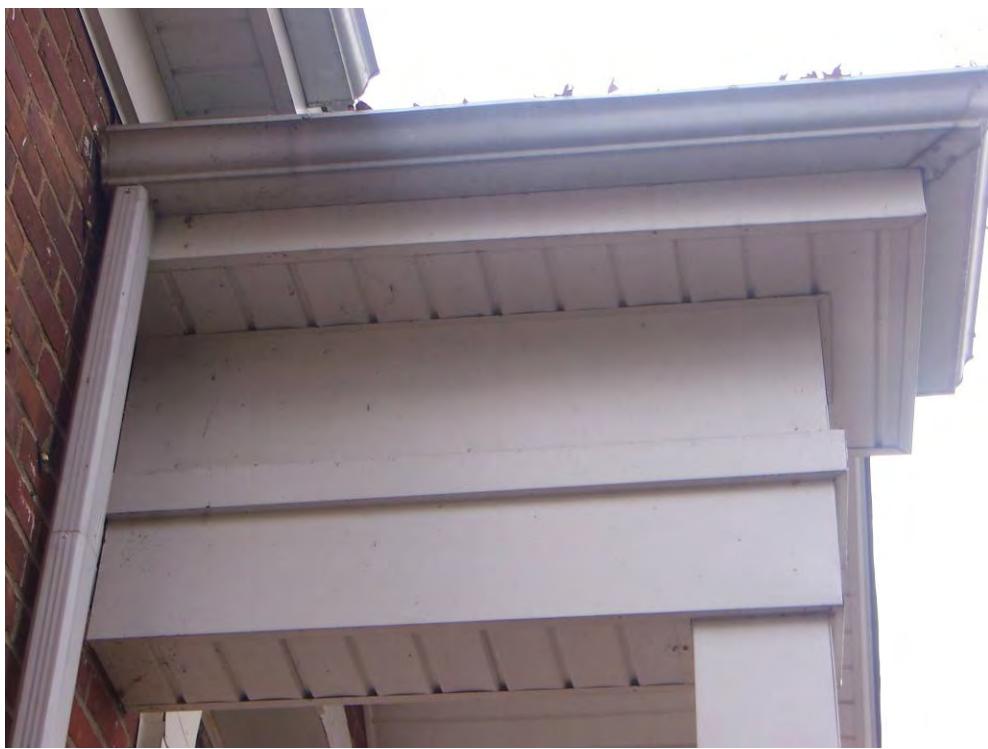
Figure 121. Metal covered decorative wood elements on front stoop.

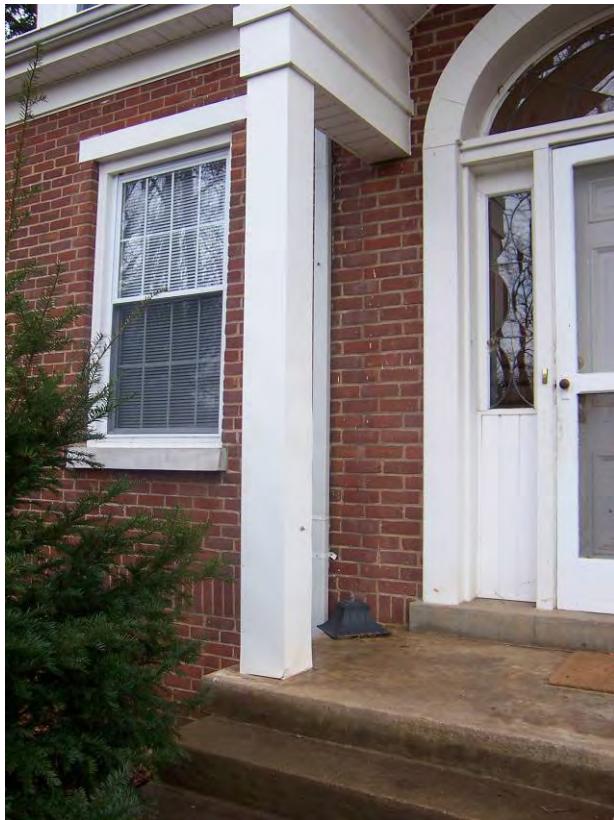
Figure 122. Metal covered front stoop post.

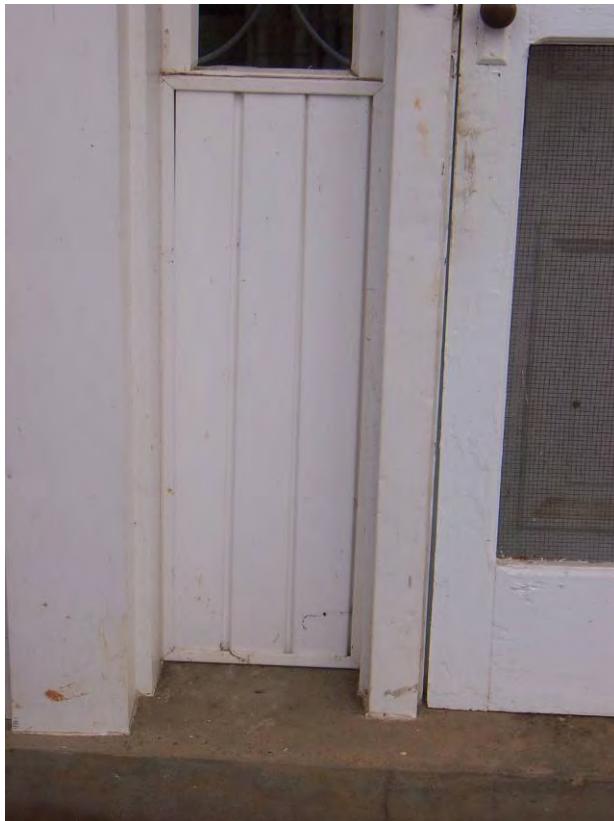
Figure 123. Metal covered wood panel.

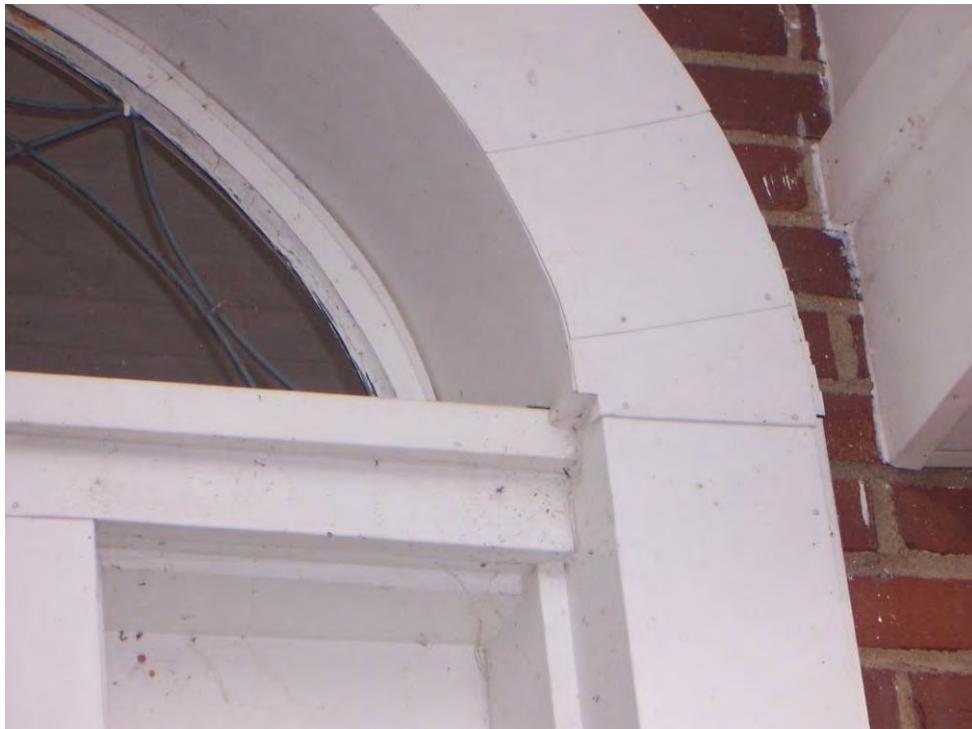
Figure 124. Metal covered decorative wood elements.

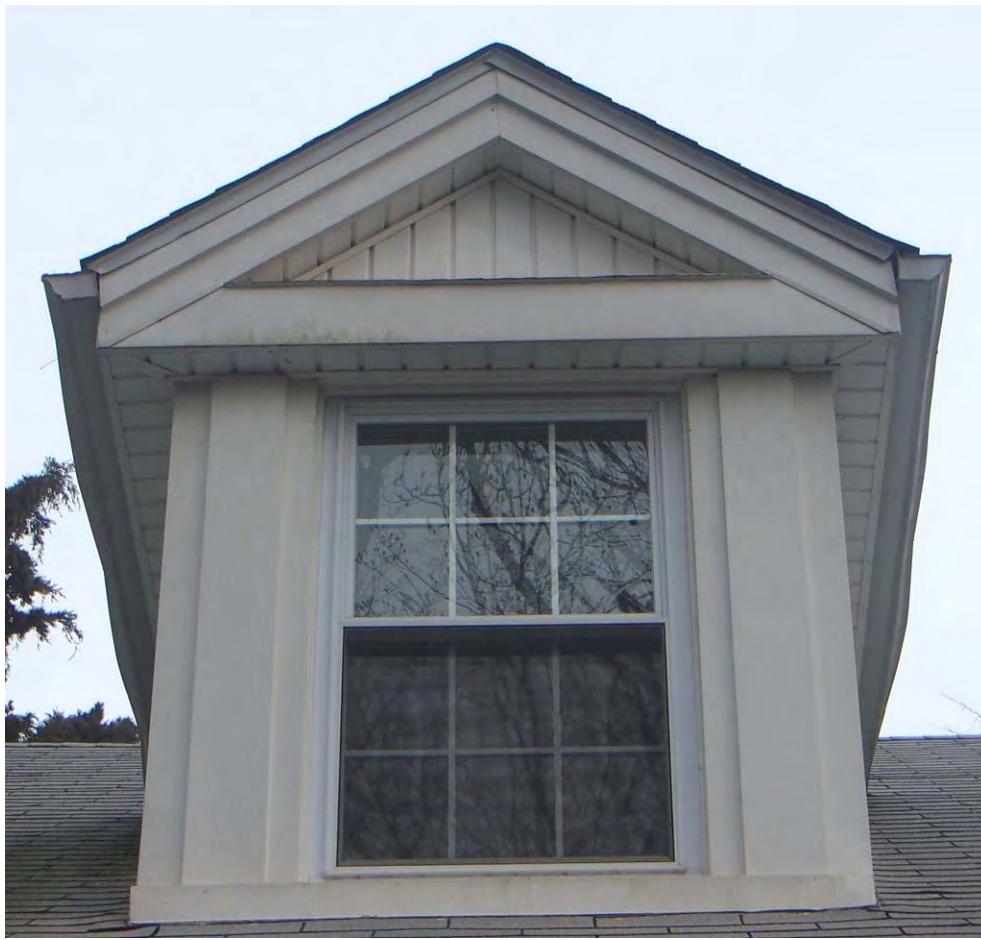
Figure 125. Metal covered decorative wood elements on dormer.

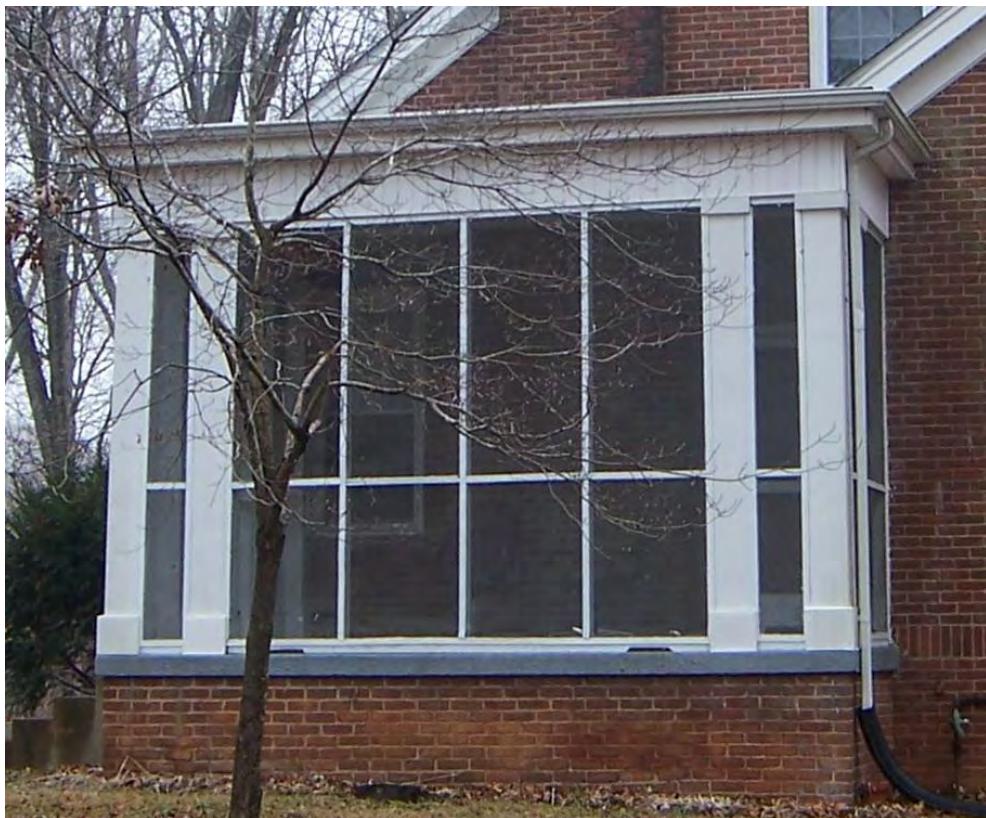
Figure 126. Metal covered decorative wood elements on screened porch.

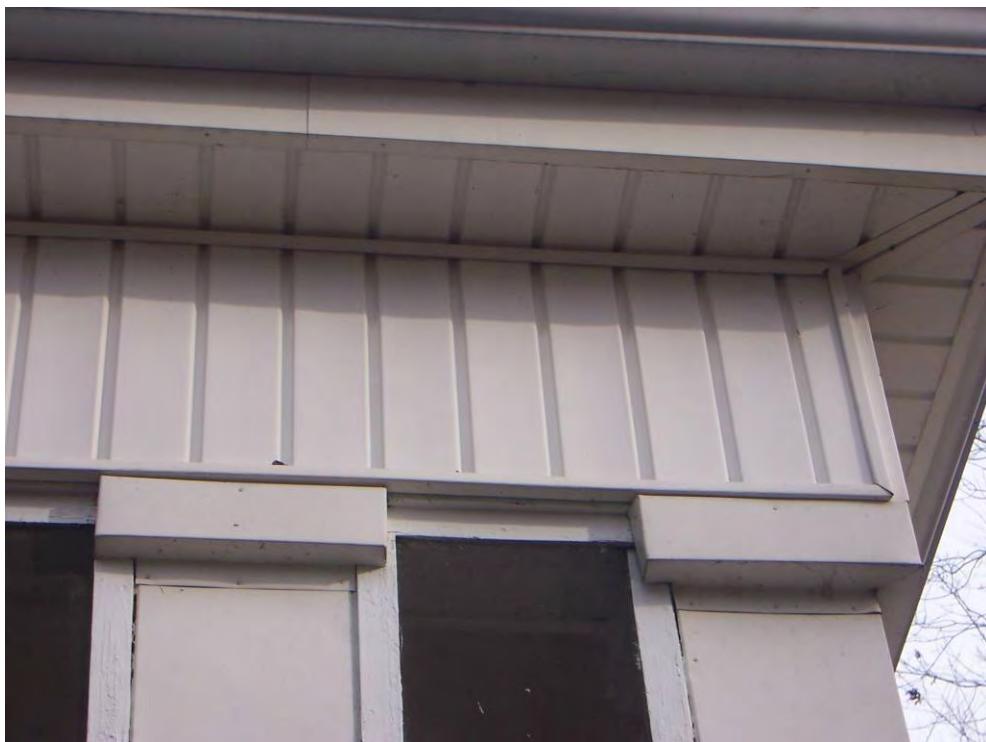
Figure 127. Metal covered decorative wood elements on screened porch.

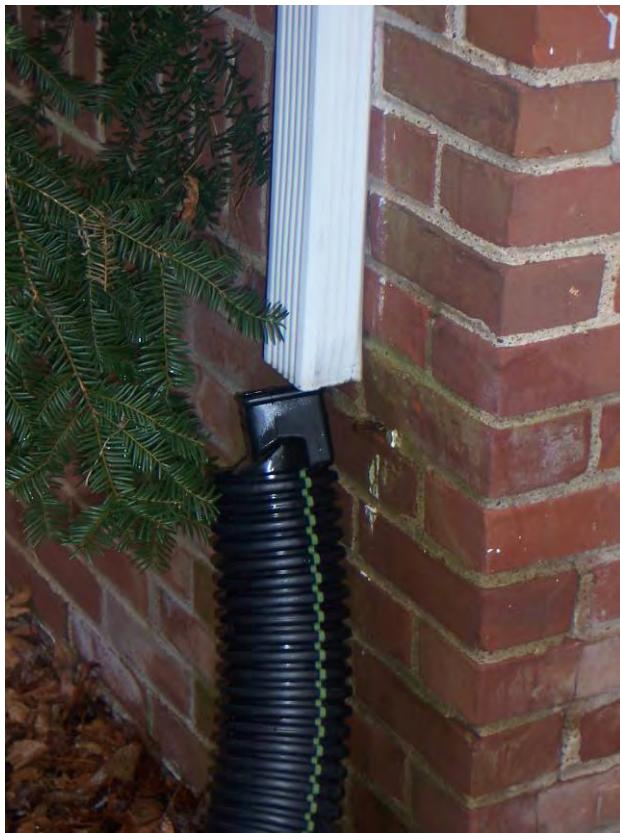
Figure 129. Downspout and plastic pipe not connected.

It is the recommendation of this manual that ALL gutters, downspouts, and plastic piping be removed from the Childers House. Seamless gutters with leaf guards need to be installed on the house so that all water is moved away from the structure. The original downspouts drained into terra cotta piping. It is the recommendation that this terra cotta piping system be rejuvenated so that the use of plastic piping is not necessary. See the above figures for specific problem areas.

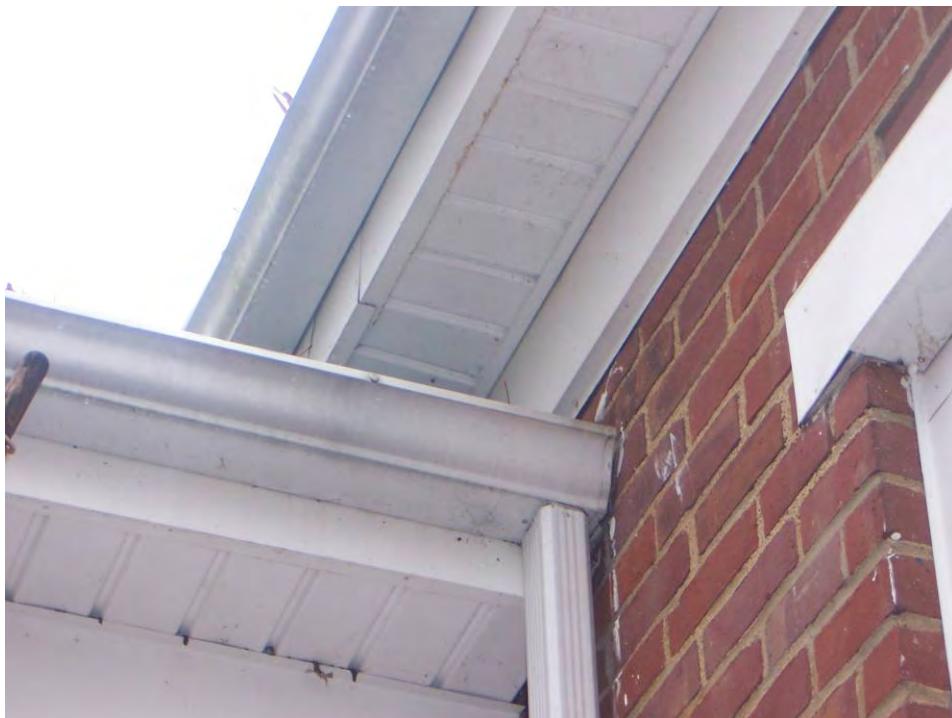
Figure 130. Gutter leading water towards building.

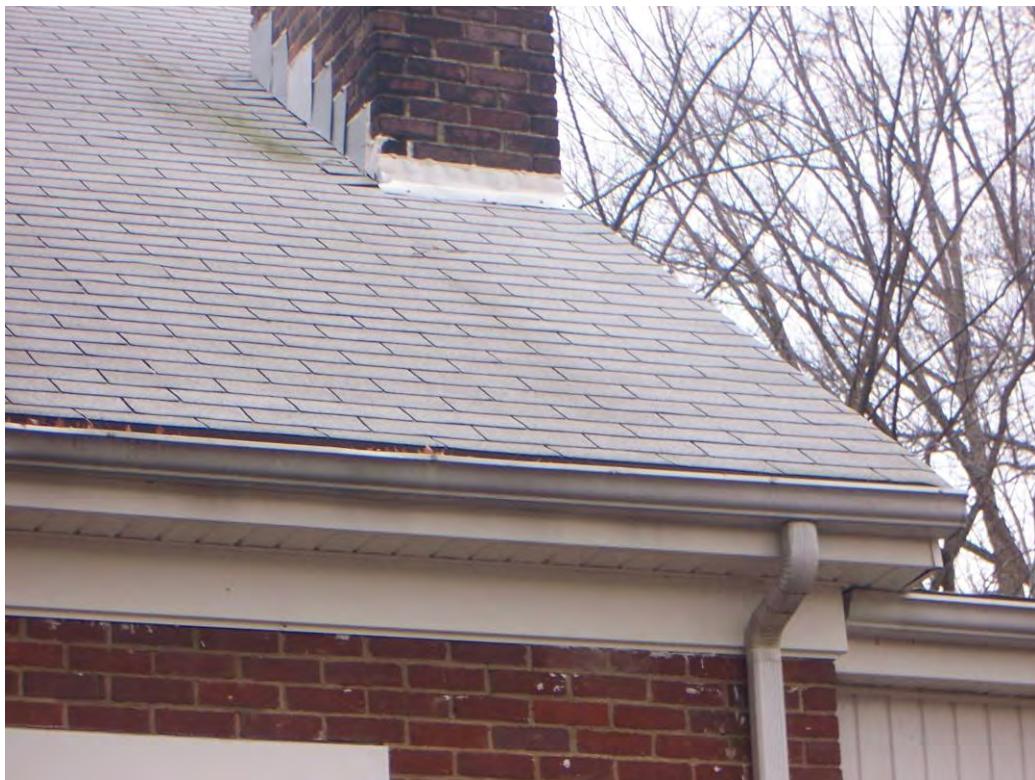
Figure 131. Gutter not cleaned out.

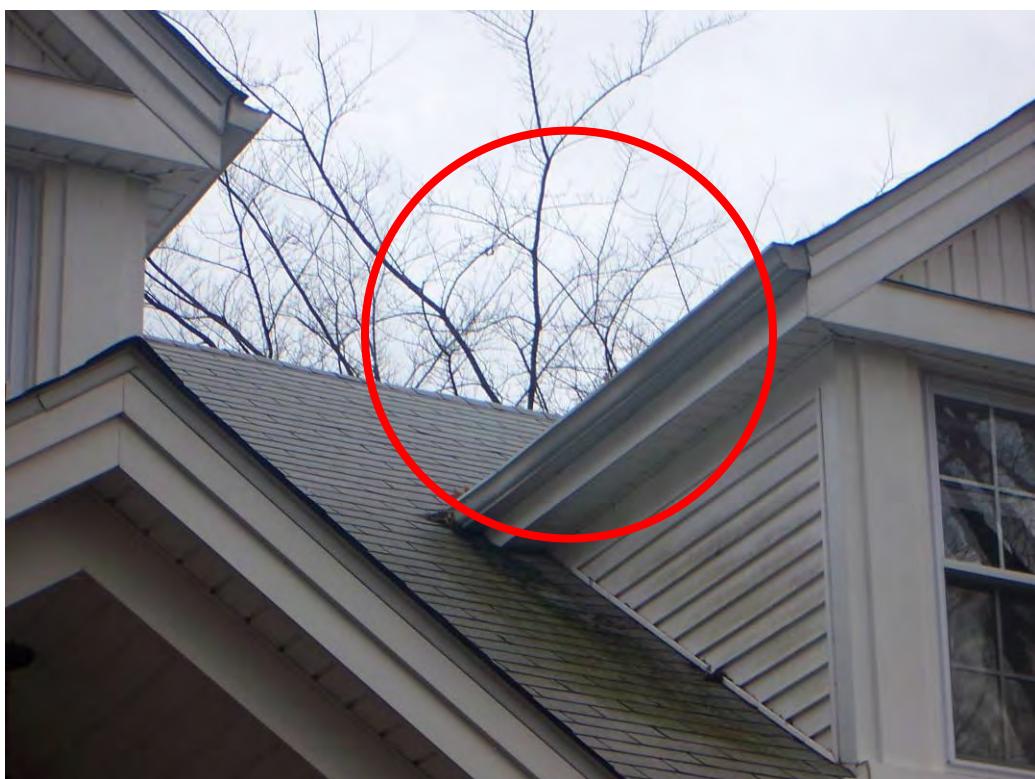
Figure 132. Dormer gutters leading towards roof and not cleaned out.

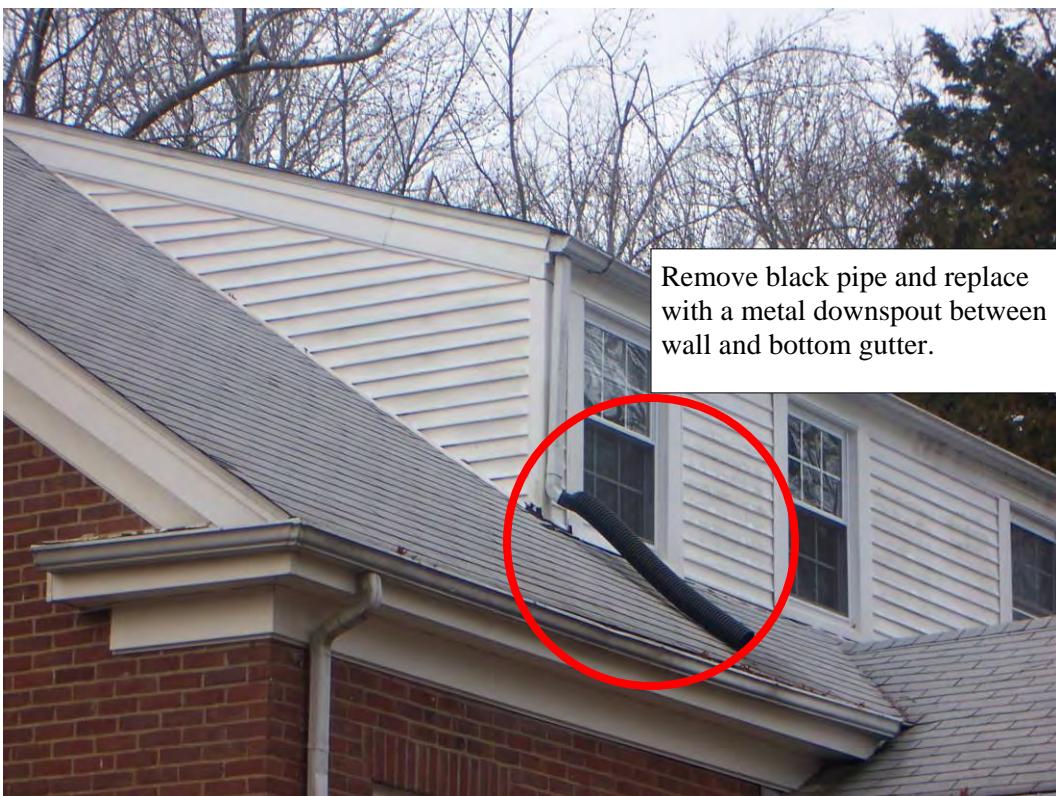
Figure 134. Plastic pipe that ends before gutter.

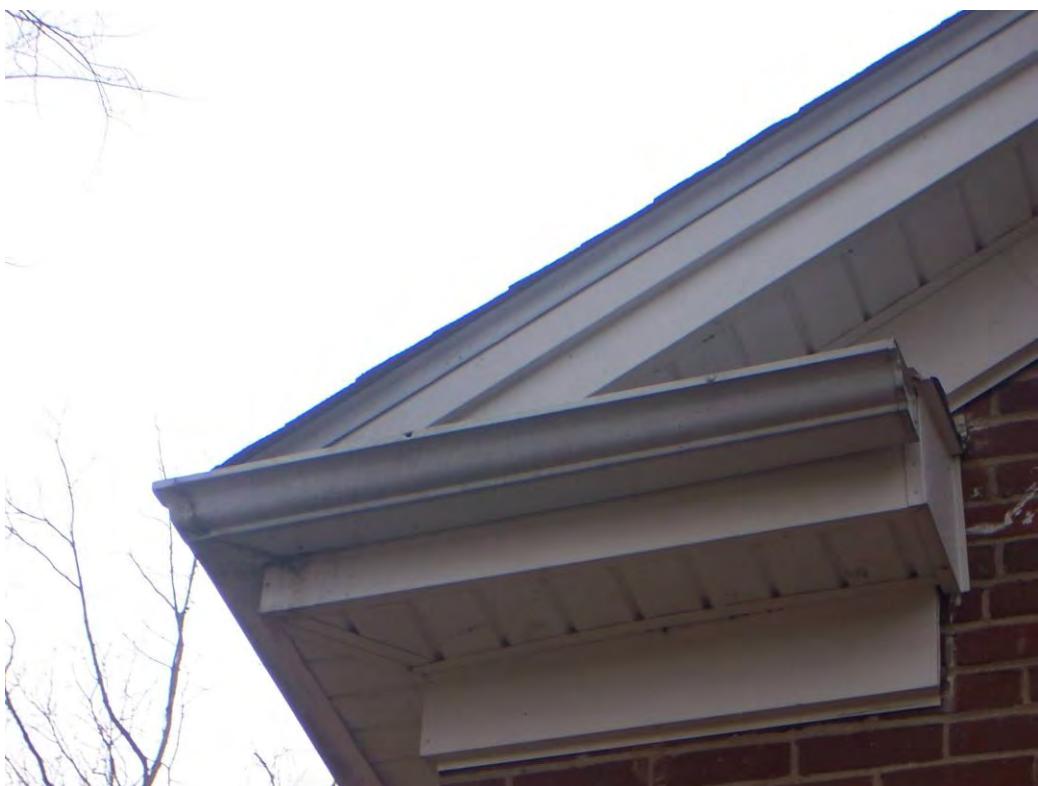
Figure 135. Unnecessary gutter.

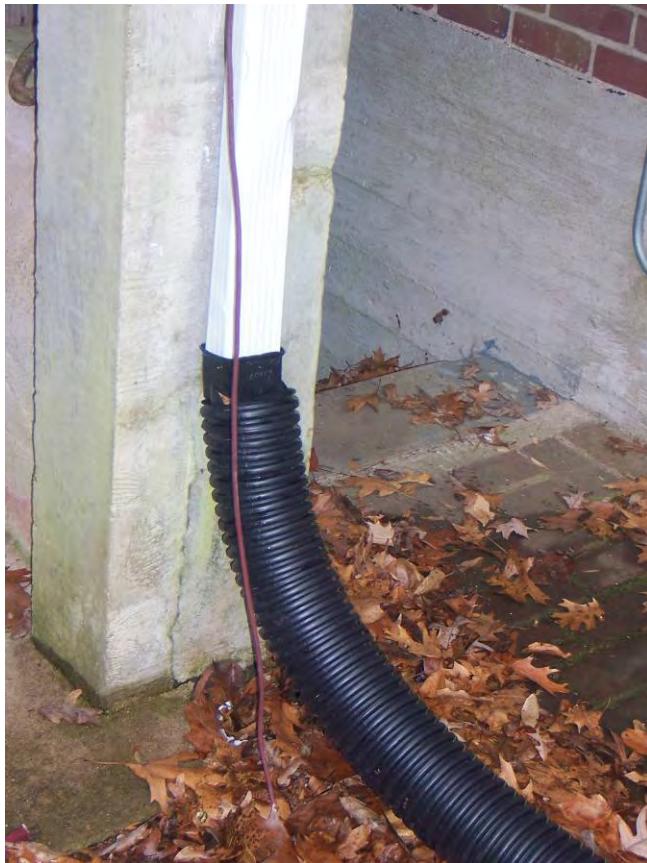
Figure 136. Leaking connection between downspout and plastic pipe.

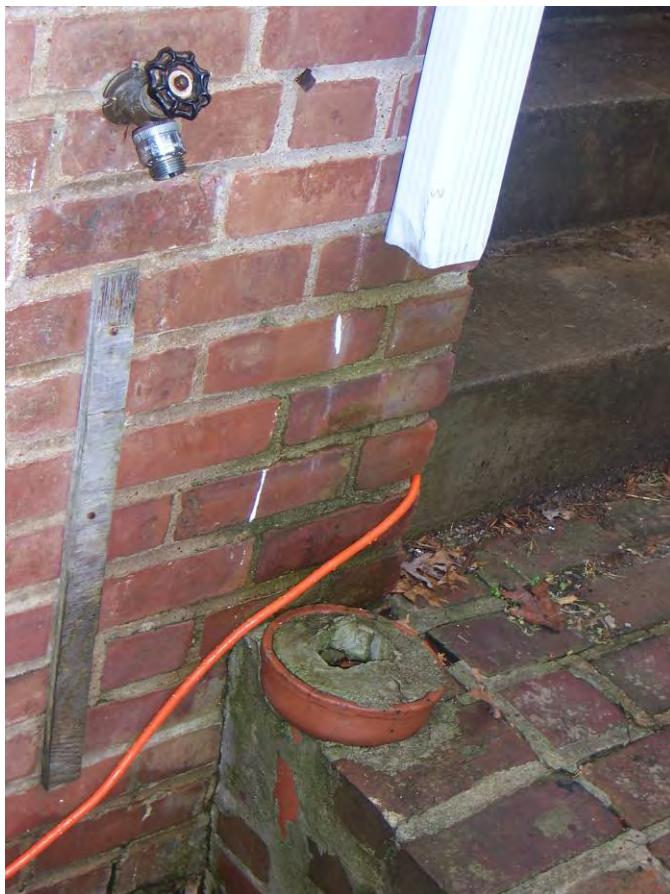
Figure 137. Downspout that does not lead to anything.

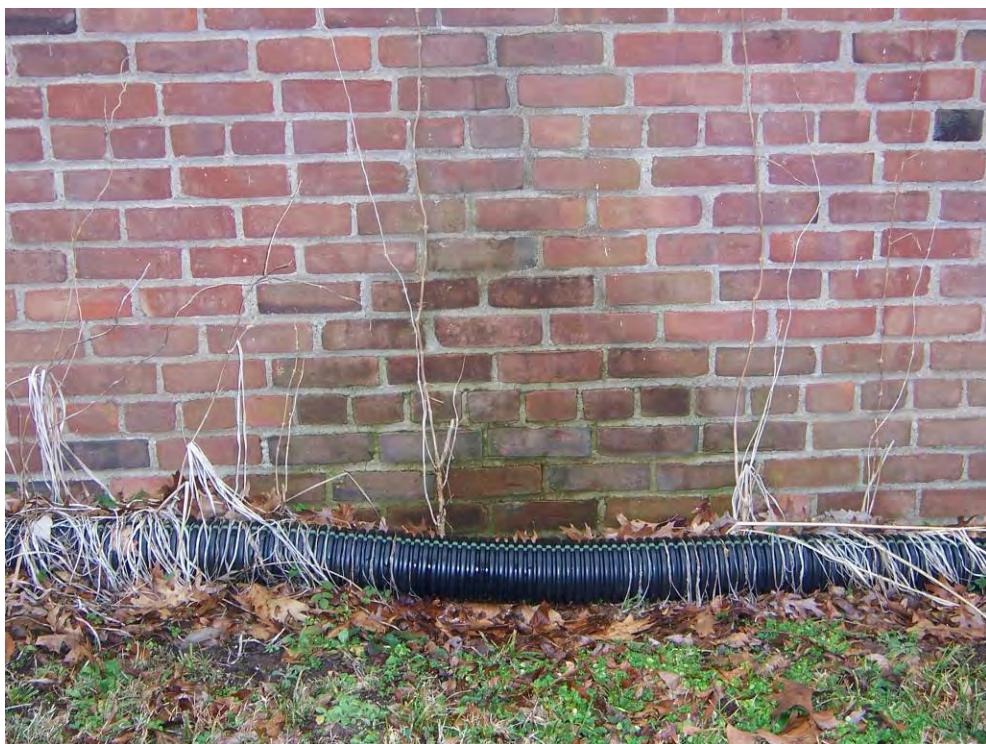
Figure 138. Leaking gutter (above) that is dripping on plastic pipe and splashing brick.

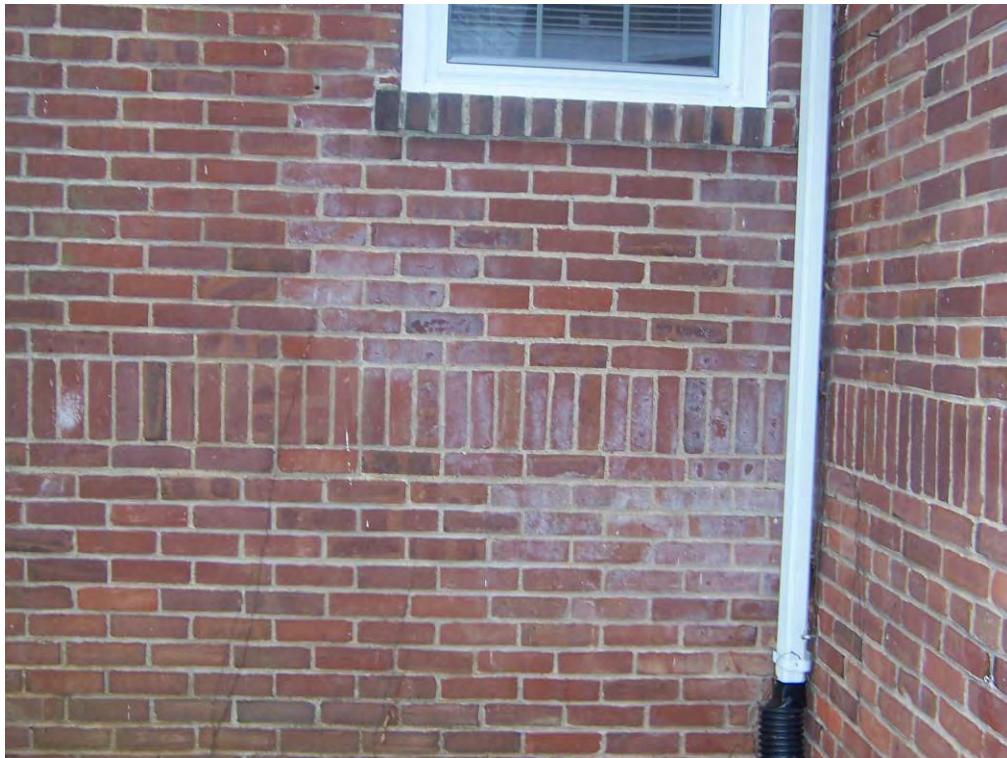
Figure 140. Salt staining on brick from gutter overflow.

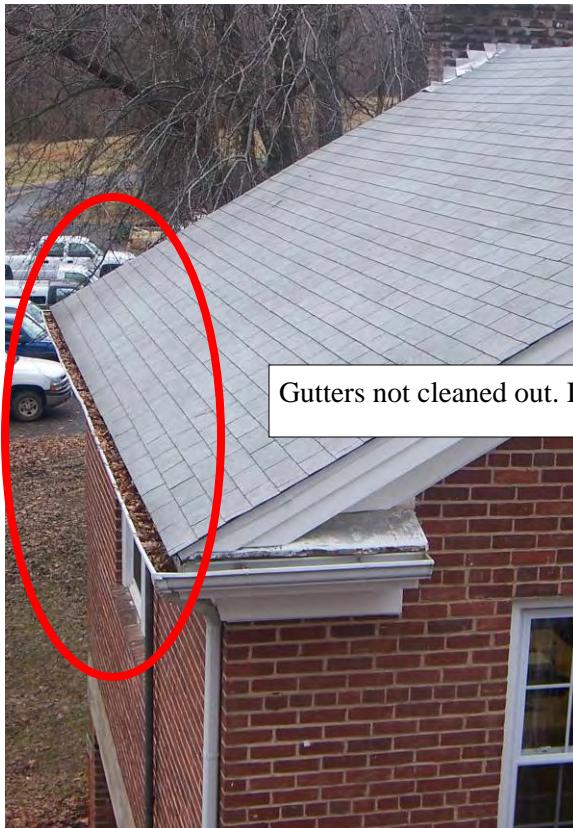
Figure 141. Gutter not cleaned out on kitchen addition.

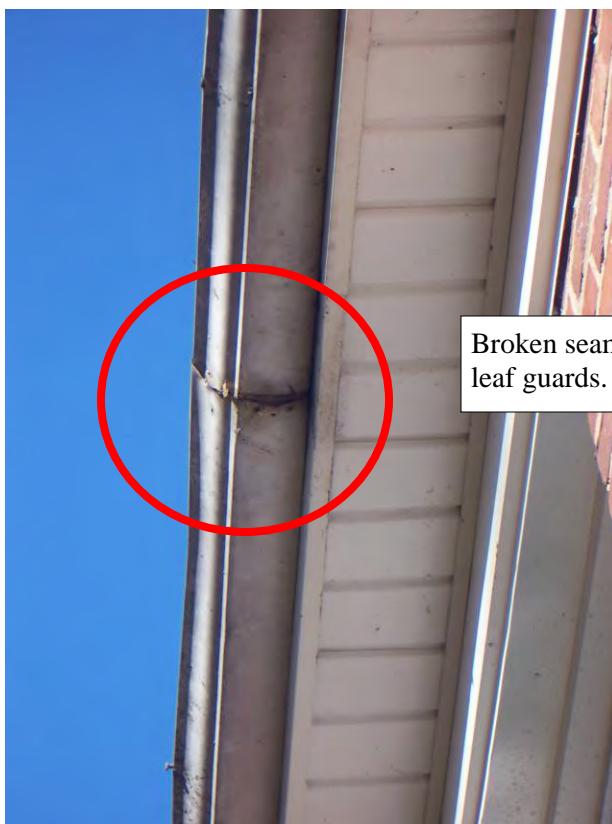
Figure 142. Gutter seal broken between two sections.

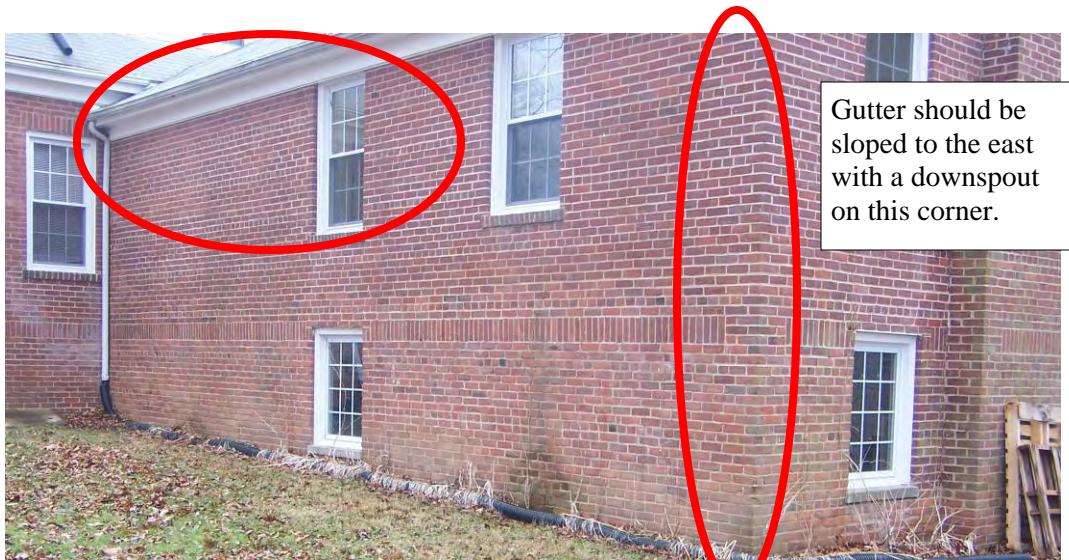
Figure 143. Gutter on kitchen addition that leads towards house.

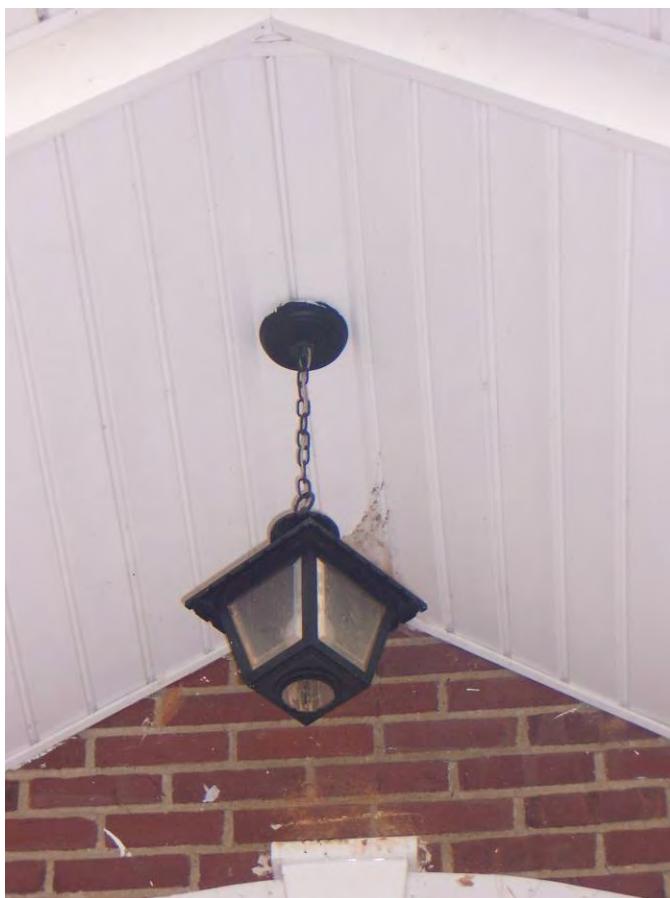
Figure 144. Non-original light fixture on front stoop.

Replace these three light fixtures with historically accurate light fixtures.

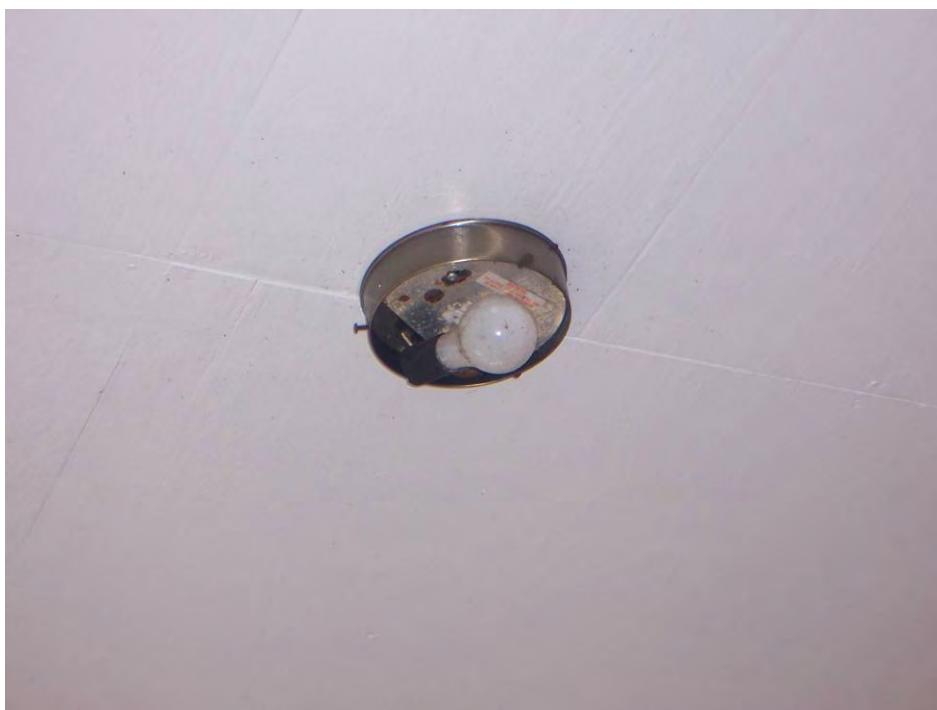
Figure 145. Non-original light fixture on screened porch.

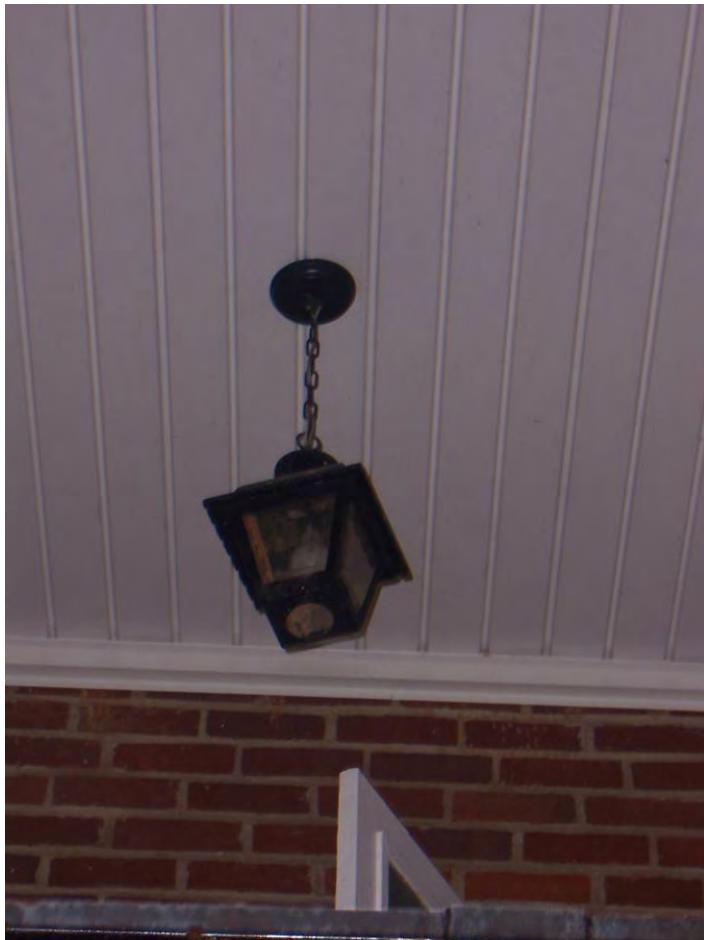
Figure 146. Non-original light fixture on hyphen balcony.

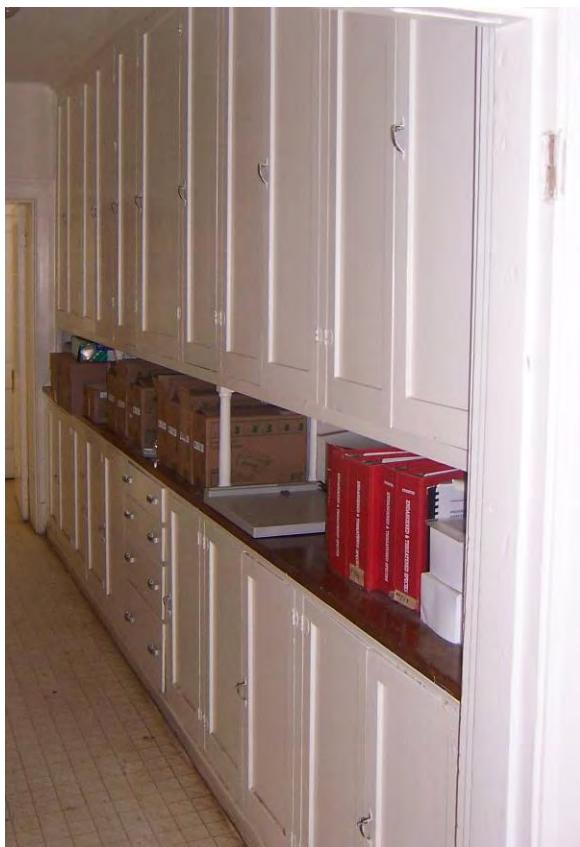
Figure 153. Cabinets in hyphen.
